Safety implications of Aggregated Retention harvesting

Greg Howard

Timber Training Tasmania

April 2008

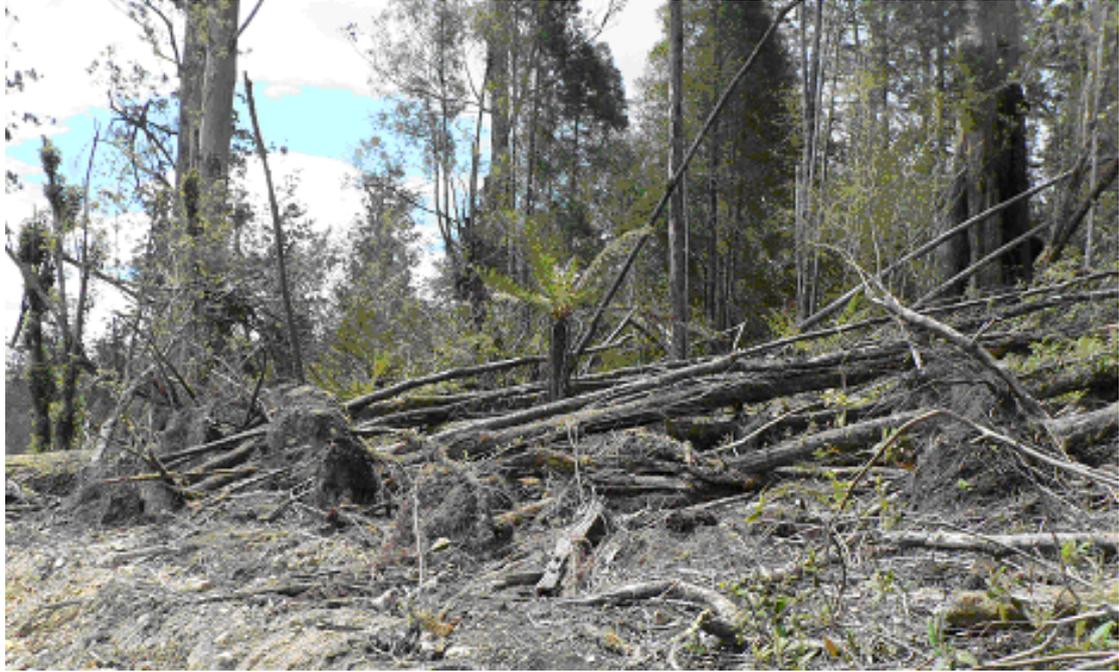
In general the smaller aggregates (those less than one hectare) were the worst affected. Some larger aggregates have sustained significant windthrow around the edges however it appears that the additional size of the aggregate has served to either absorb or deflect the wind strength therefore sparing the remainder of the aggregate (Figure 1).

Figure 1. Windthrown trees on edge of aggregate in SX018E.

- a. Wind modelling for coupes during planning.
- b. Placement of aggregates in less wind prone areas of coupes.
- c. Retained aggregates to be larger in area with no feathered edges.
- d. Incorporation of aggregates into the harvest boundaries.

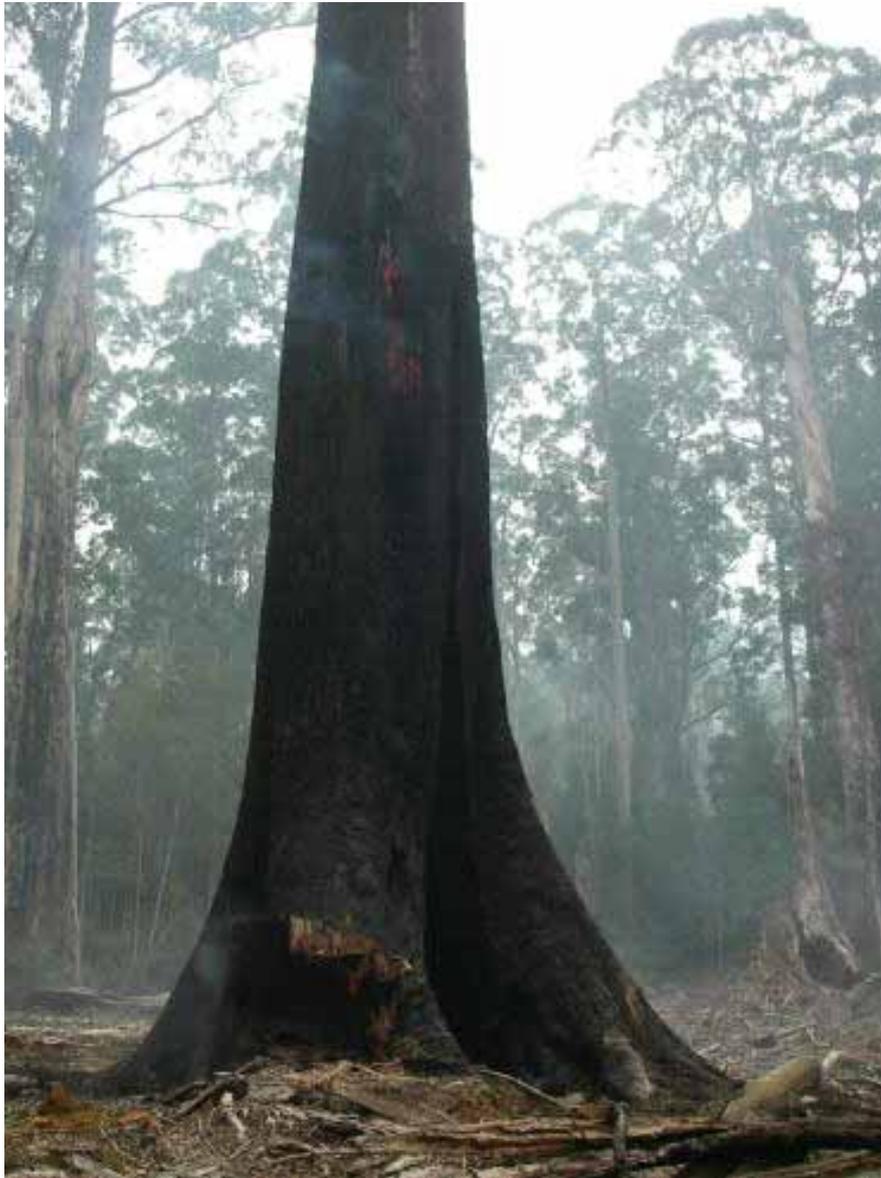
The majority of the hazardous trees are situated within the retained aggregates indicating the need for more detailed assessment of trees during the harvesting process and greater attention to burning procedures to ensure that oldgrowth trees especially do not sustain severe fire damage (Figure 2).

Figure 2. An oldgrowth tree on fire in SX018E. This tree may well subsequently die and therefore present an ongoing risk to subsequent operations.

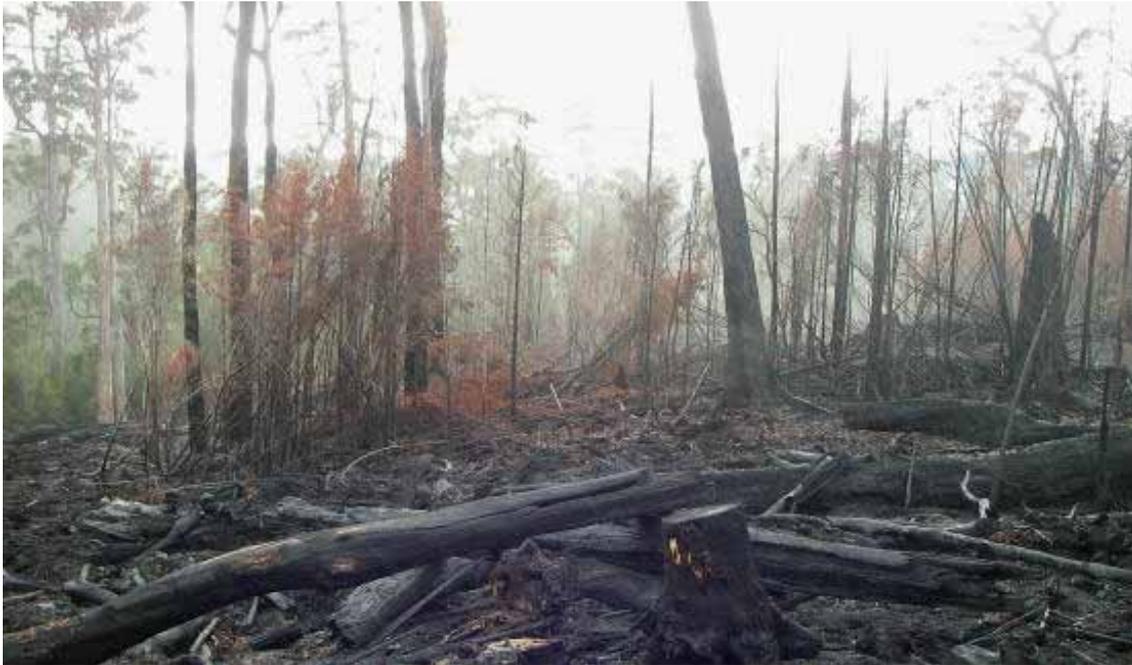
Severe burning of the retained aggregates was most common where the aggregates were smaller and contained significant windthrow (Figure 3). This result is no doubt caused by the fact that smaller aggregates would have dried out more because of increased penetration of the sunlight and the increased fuel load close to the ground caused by the windthrow. A good example of this can be seen in EP081B where the smaller aggregates in the western section of the coupe have been almost completely scorched whereas the two larger aggregates in the eastern section are almost untouched (Figure 4).

Figure 3. Severely burnt aggregate in SX007A.

- a. Coupes to be lit later in the afternoon to take advantage of rising humidity and falling temperatures.
- b. Increased use of manual lighting of coupes.
- c. Heavy fuel loads to be moved further away from aggregates on the windward side.
- d. Increased aggregate size.
- e. Reduced windthrow in aggregates.

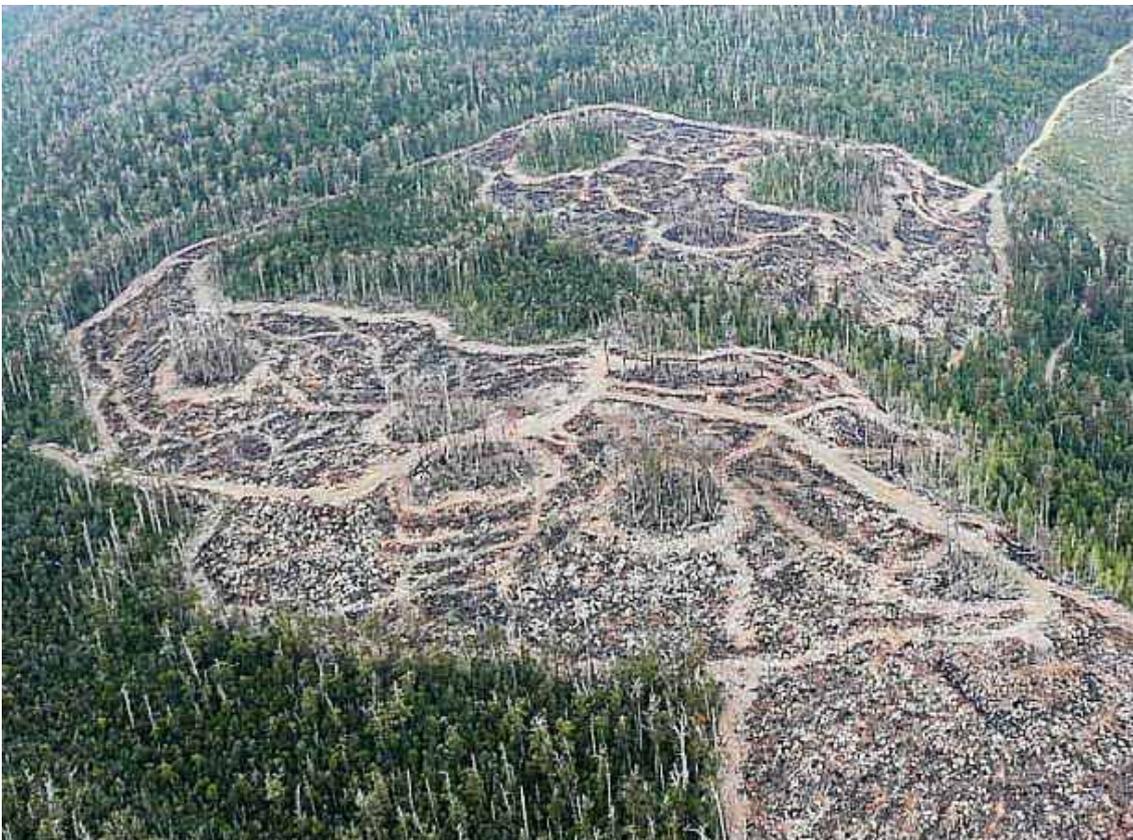
Figure 4. Results of the regeneration burn in EP081B. The six smaller aggregates in the foreground section of the coupe and the one small aggregate in the far section have sustained significant fire damage while the two larger aggregates in the far section have survived relatively unscathed.
